LISBOA 2010 MAY 25/28 16th World Meeting

Ivan Legac, Hrvoje Pilko, Nikola Šubić
University of Zagreb - Croatia

Introduction of Roundabouts in Croatia – - preliminary Experiences

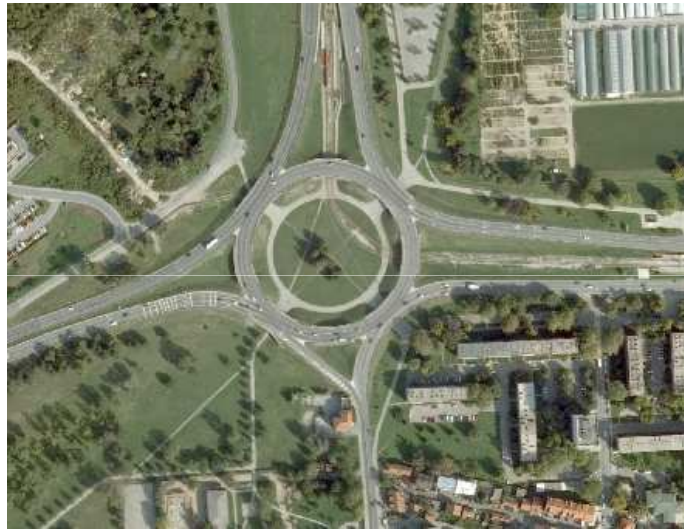
Figure 2. Big roundabout (Dv = 148 m, n = 3/3) Jadr. Ave. – Remet. Str. at entrance in Zagreb, 1980.

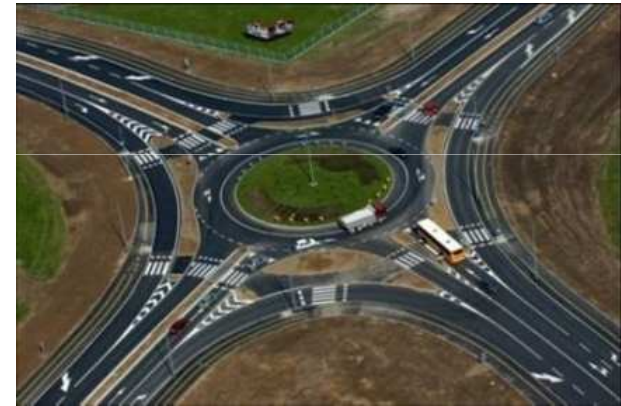
Figure 3. New solution of roundabout, (Varaždin - bypyss south, 2005.)

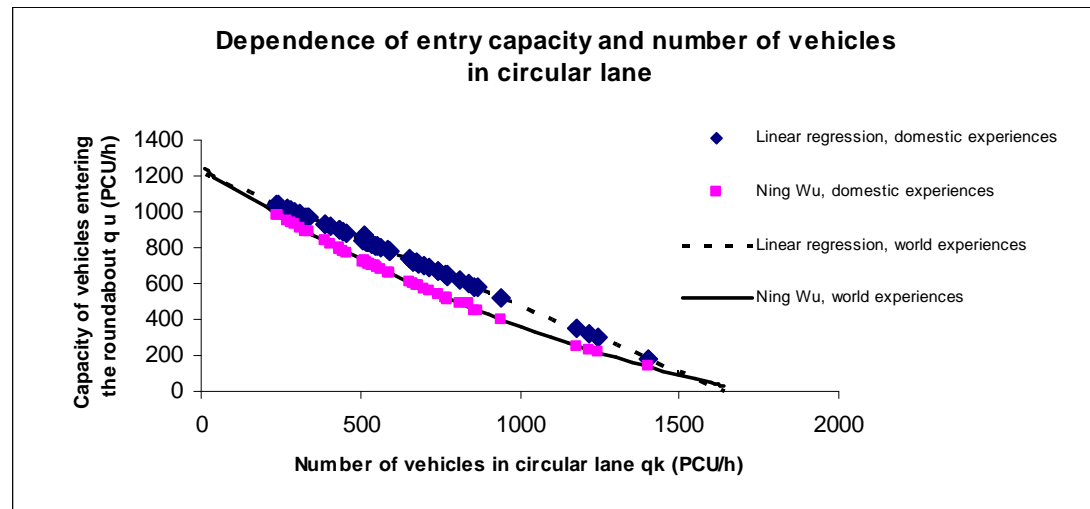
Figure 4. Measured q_u/q_k (Linear regr., Ning Wu) in world and in Croatia

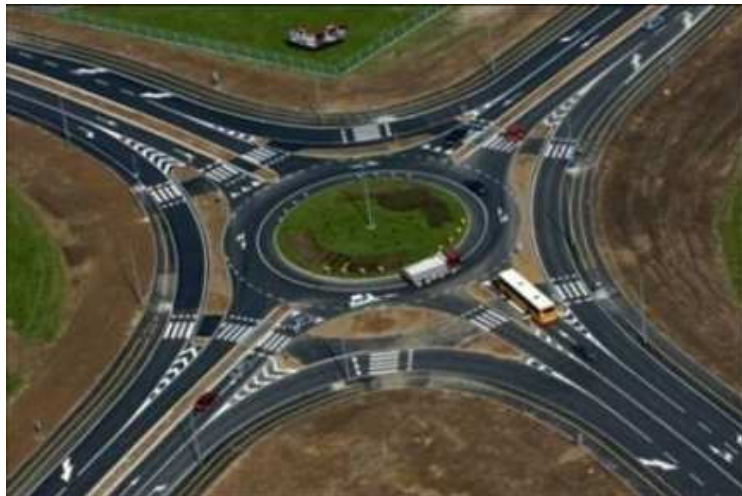
Figure 6. Direct weaving of cars, bicyclists and pedestrians by independent guiding (Varaždin bypass, 2005)
